STM32H742x/743xI/G, STM32H750xB and STM32H753xI device errata

It gives a summary and a description of the device errata, with respect to the device datasheet and reference manual RM0433.

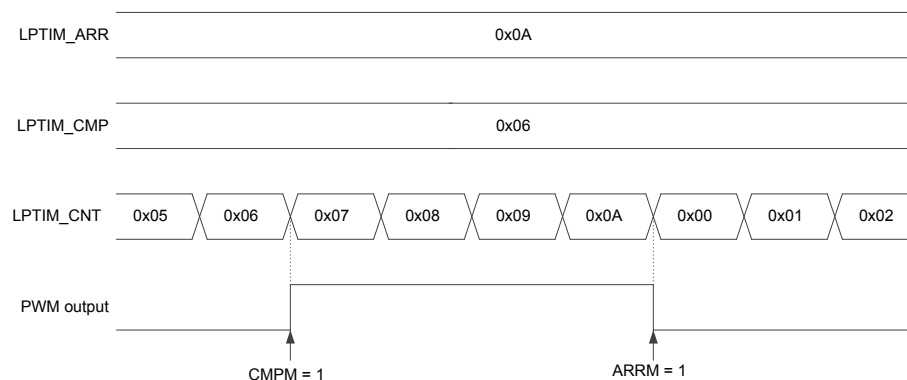
Figure 1. Example of PWM output mode

The following waveform gives the example of PWM output mode and the effect of the delay:

Set the compare value to the desired value minus 1. For instance in order to generate a compare match when LPTM_CNT = 0x08, set the compare value to 0x07.

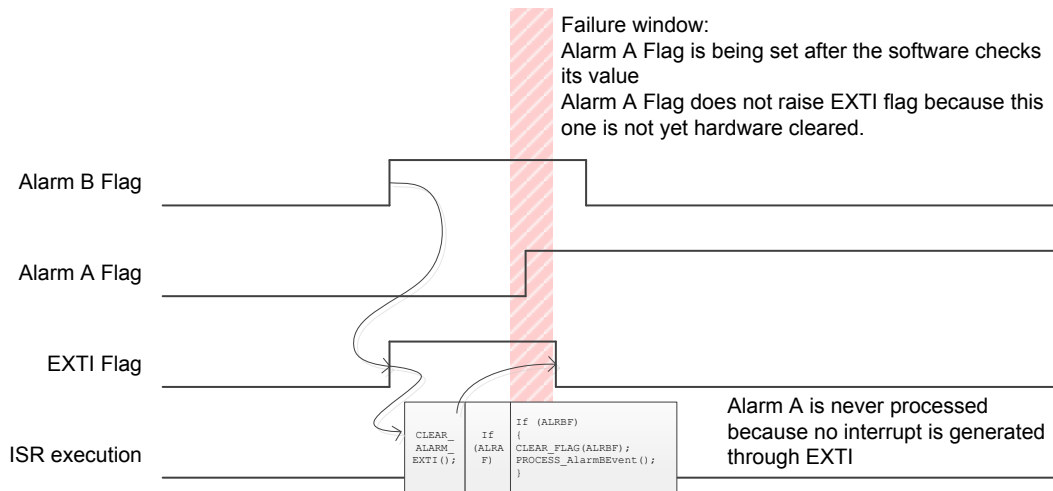
Figure 2. Masked RTC interrupt

The following code example and figure illustrate the failure mechanism: The Alarm A event is lost (fails to generate interrupt) as it occurs in the failure window, that is, after checking the Alarm A event flag but before the effective clear of the EXTI interrupt flag by hardware. The effective clear of the EXTI interrupt flag is delayed with respect to the software instruction to clear it.
