STM32H742x/743xI/G, STM32H750xB and STM32H753xI device errata

It gives a summary and a description of the device errata, with respect to the device datasheet and reference manual RM0433.

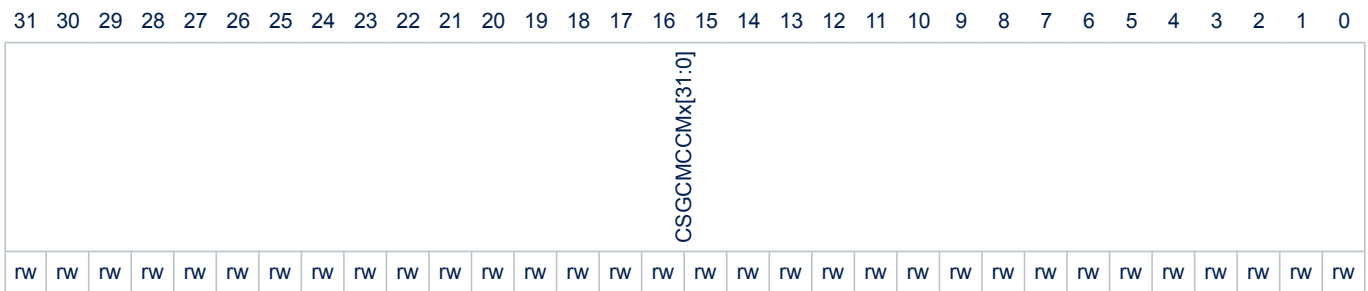
CRYP context swap GCM-CCM registers (CRYP_CSGCMCCMxR)

In some reference manuals, the *CRYP context swap GCM-CCM registers (CRYP_CSGCMCCMxR)* section is missing in the *cryptographic processor (CRYP)* chapter. These registers, described next, are required to run the suspend/resume operations for the GCM and CCM chaining modes.
